StreamSmart Data Report Highlights:

Water Quality across the Beaver Lake Watershed

January 2026

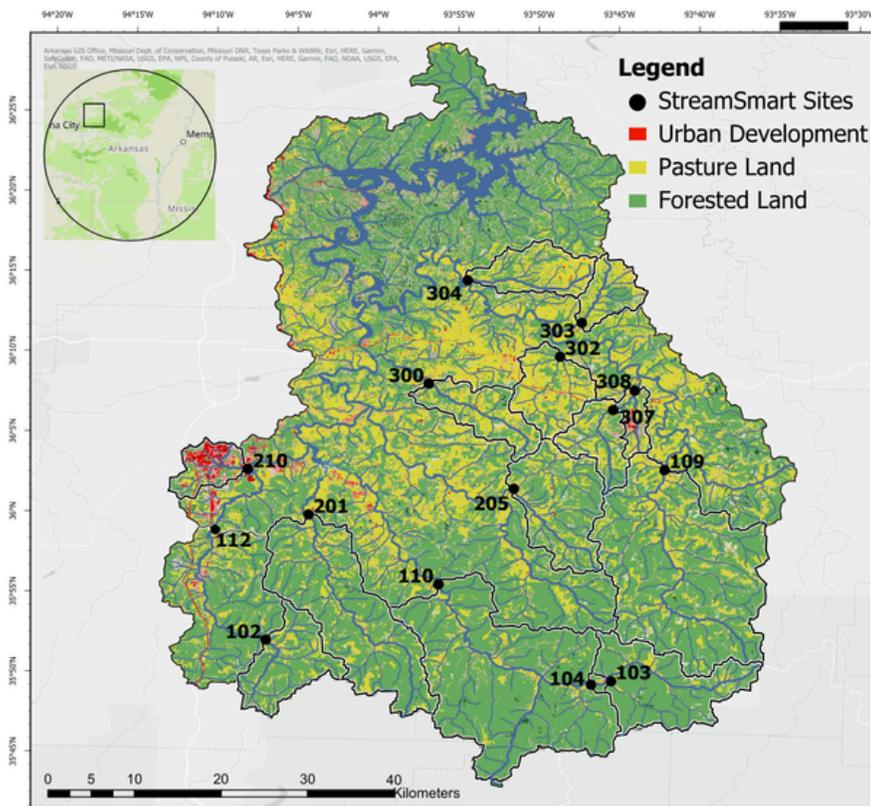
Figure 1. Map of the Beaver Lake Watershed colored by land use. StreamSmart monitoring sites are marked with black circles.

This report summarizes findings from the StreamSmart Citizen Science Program, where volunteers collect long-term water quality data across the Beaver Lake Watershed (Figure 1). While the full technical report is available online¹, this document highlights some of the key findings.

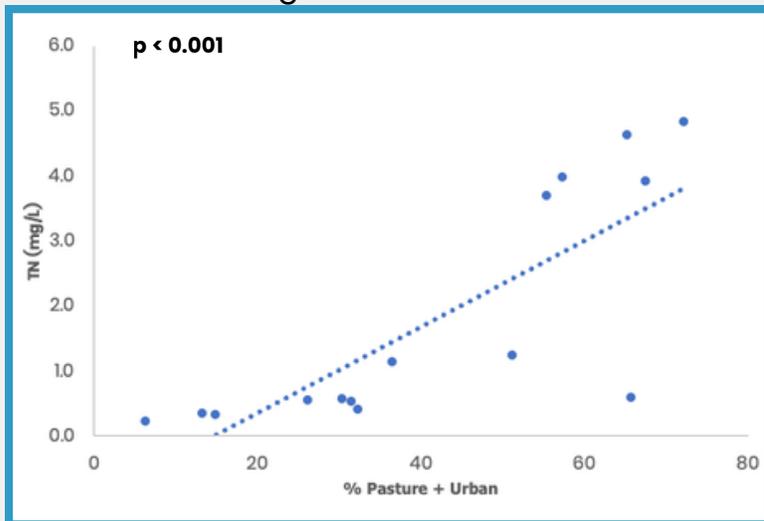
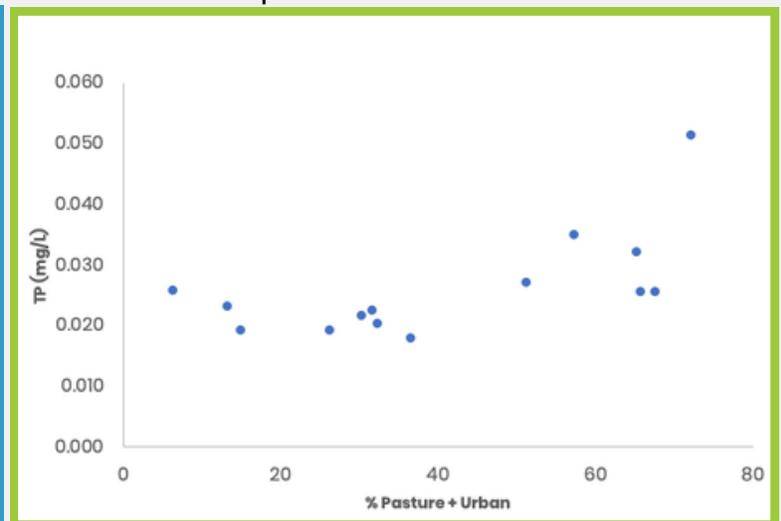
Land Use Compared to Nutrient Concentrations

Streams draining more pasture and urban areas tend to have higher nutrient concentrations (Figure 2). Total nitrogen (TN) is very strongly linked to pasture and urban land use ($p < 0.001$). Total phosphorus (TP) appears to increase along the same land use gradient, although the relationship is not statistically significant ($p > 0.05$). These findings highlight that agricultural and urban areas can contribute to nutrient pollution in water ways, typically from rainfall runoff from the landscape. We can change how we manage these lands to improve water quality.

Figure 2. Relationships between land use and total nitrogen (left) and total phosphorus (right) concentrations (from Feb 2022 – Dec 2025) for all active StreamSmart sites.

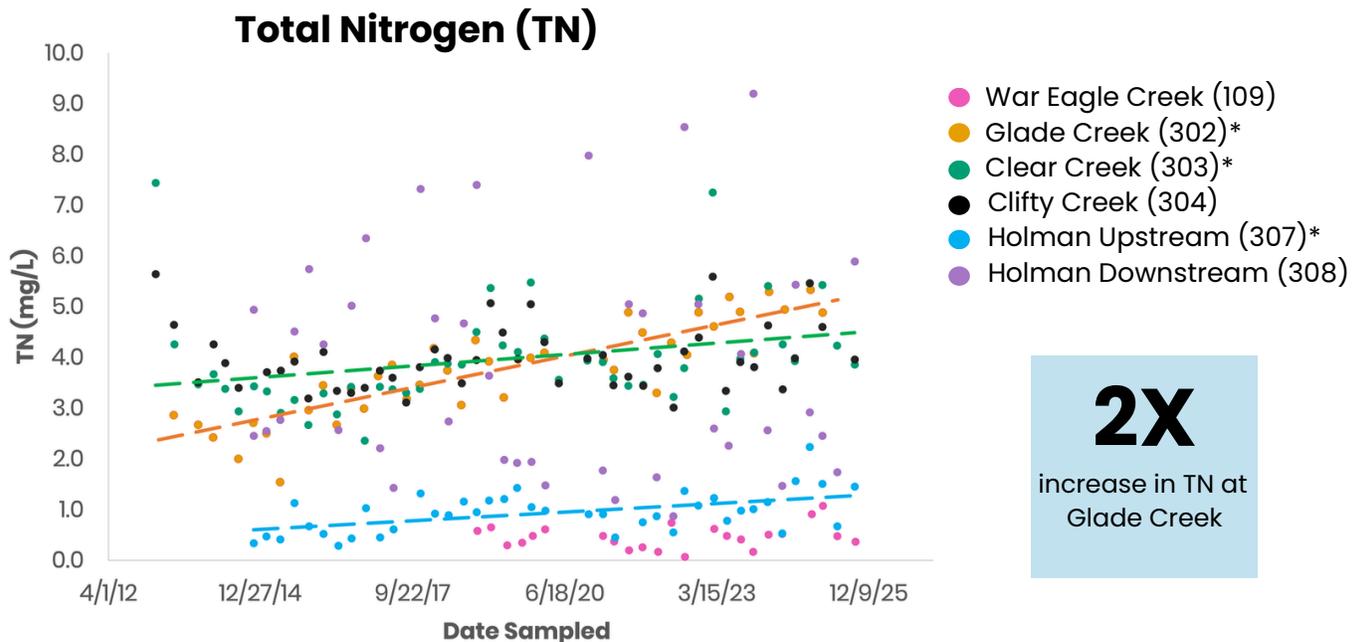
Glade Creek, Clear Creek, and Holman Creek Upstream from Huntsville show significant increases in total nitrogen (TN) over time (Figure 3). Clifty Creek and Holman Creek Downstream from Huntsville have consistently high TN concentrations ranging from about 2 mg/L up to over 7 mg/L in some cases.

Figure 3: Total nitrogen concentrations over time at each site in the WEC subwatershed. *Dashed lines indicate statistically significant increases over time.

StreamSmart volunteers monitor six sites in this subwatershed – one on the upstream portion of WEC and five on tributaries flowing into it further downstream. The data show increasing nitrogen (Figure 3) and phosphorus (Figure 4) at some of these sites flowing into WEC (statistically significant, $p < 0.01$).

- Nutrient concentrations are increasing at three sites near WEC – Glade Creek, Clear Creek, and Holman Creek Upstream from Huntsville.
- These three sites are surrounded by more pastureland or are in rapidly developing areas, such as Glade Creek and Clear Creek.¹
- The higher nutrients in these smaller tributaries are likely contributing to the algal growth and decreased oxygen levels in War Eagle Creek.

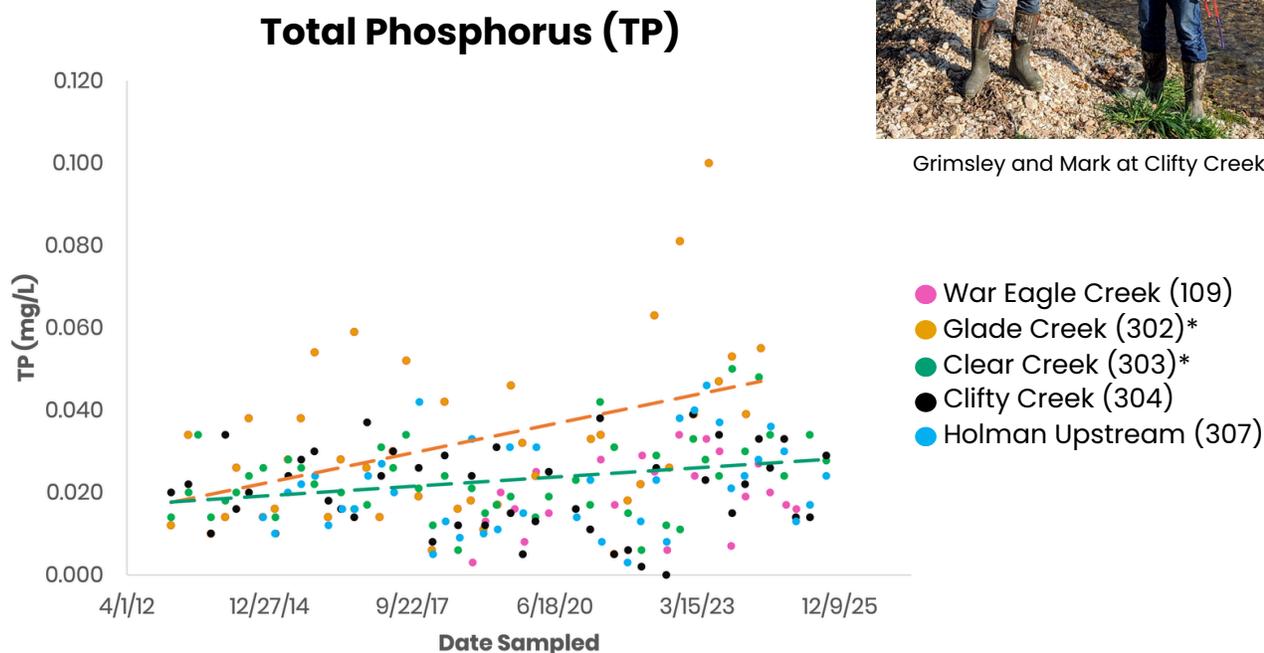
Glade Creek and Clear Creek also show significant increases in total phosphorus (TP) over time (Figure 4). Holman Creek Downstream from Huntsville has maintained very high TP concentrations over time, ranging from 0.024 mg/L up to over 1.0 mg/L.

Figure 3: Total phosphorus concentrations over time at each site in the WEC subwatershed. *Dashed lines indicate statistically significant increases over time. **Holman Downstream had such high phosphorus values (0.024-1.042 mg/L) it was removed to prevent axis distortion.

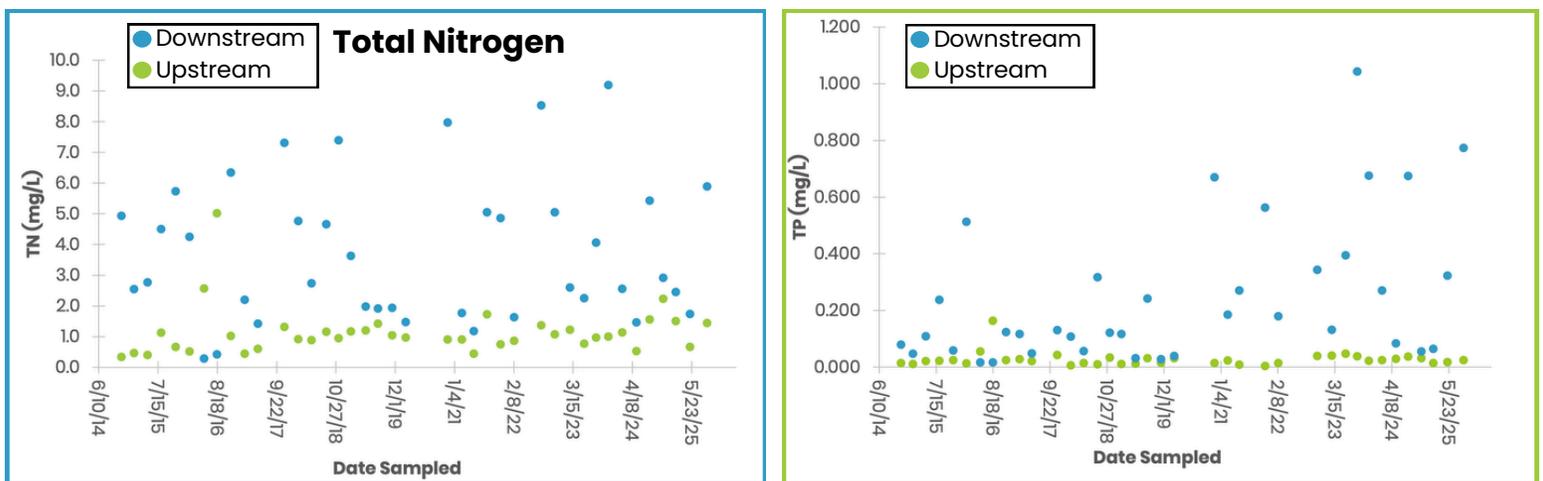
Stream Smart data show significant differences in nutrient concentrations between the upstream and downstream sites. Concentrations at the upstream site generally remain low, but downstream concentrations frequently exceed thresholds of concern. These elevated nutrient concentrations are likely driven primarily by the WWTP effluent (a point source), with additional contributions from agricultural and urban land use (nonpoint sources).

Figure 4. Total nitrogen and total phosphorus concentrations over time at Holman Creek Upstream and Downstream sites.

- Holman Downstream had total nitrogen as high as **9.20 mg/L** and total phosphorus over **1.0 mg/L**.
- These high nutrient concentrations are likely influenced by land use and the WWTP, which both impact water quality.
