Western Table Rock Lake Watershed Management Plan

July 9, 2012

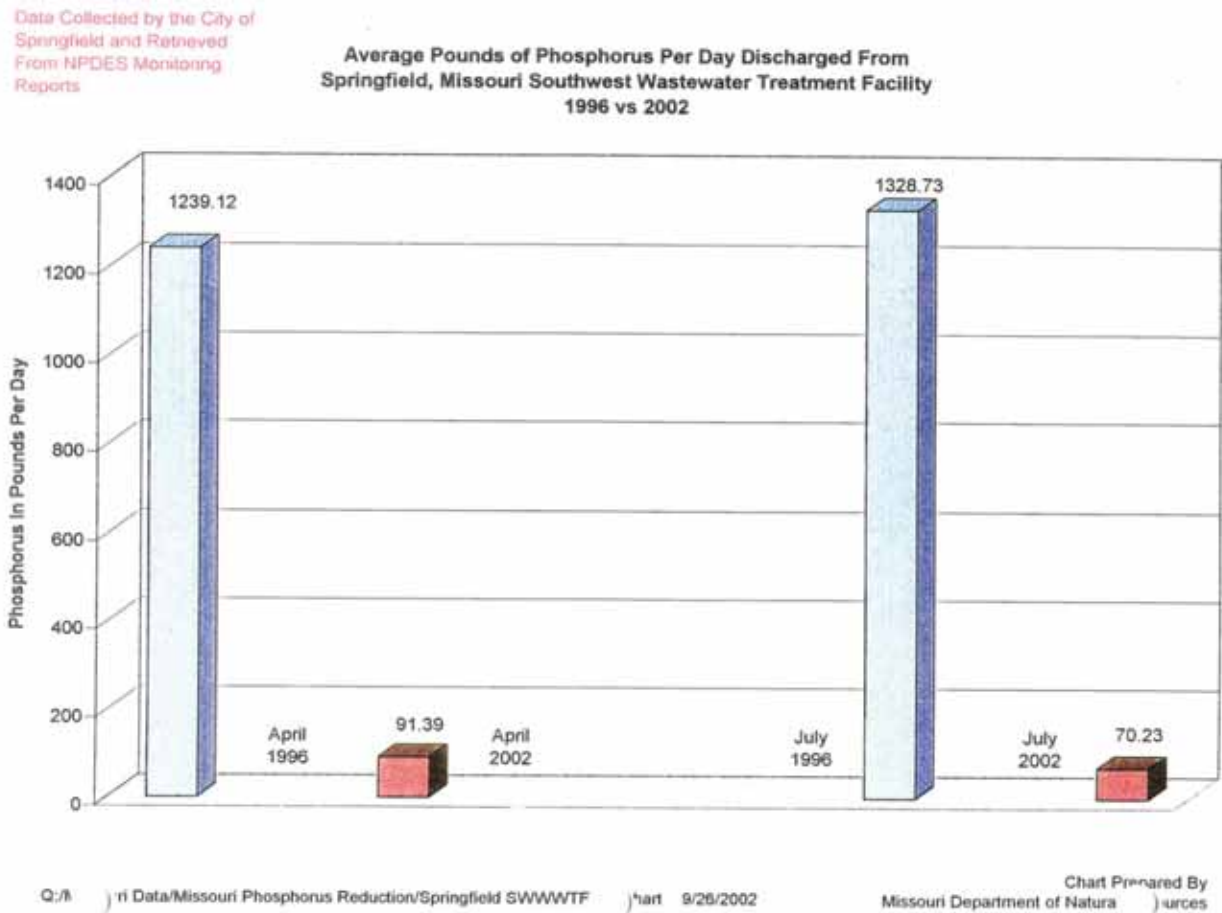
FIGURE 5. CITY OF SPRINGFIELD SOUTHWEST WASTEWATER TREATMENT PLANT PHOSPHORUS DECREASES FROM 1996 TO 2002. (SOURCE: CITY OF SPRINGFIELD, MO)

The major tributaries of Table Rock Lake have played a large role in nutrient input to the lake through varying types of anthropological impacts including urban development, residential development and agricultural development. For example the Kings River site #7 has higher TP levels than the James River site #4.5. Kings River arm has more agricultural impacts than the James River which has also been regulated for TP from the City of Springfield municipal waste discharge since 2001 (Figure 5).

Cumulative nutrient loading in streams results from point sources and nonpoint sources (NPS) of pollution that occur in association with development, both urban and agricultural. Point sources of pollution including municipal and community wastewater treatment plants producing more than 3,000 gallons per day are currently regulated to maintain a National Pollution Discharge Elimination Systems (NPDES) permit. This permit is used to monitor pollution levels in their discharge and regulate the nutrient loading that is allowed in the discharge. Figure 5 shows the decrease in phosphorus outputs that the City of Springfield Southwest Wastewater Treatment Plant was able to achieve as a result of additional phosphorus removal facilities installed at the plant in 2001.

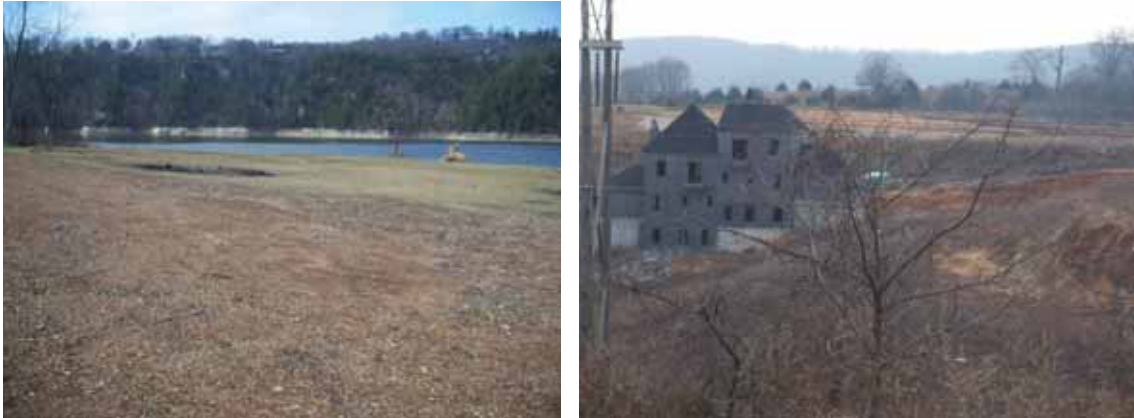
Above: Images of Table Rock lakeside areas that have been cleared of vegetation for community access (left) and for resort/condo development (right).

With the increasing number of homes and commercial developments being built along the lake the potential for stormwater runoff issues is becoming a huge concern. The growth in urban land use over the years reflects more development in the watershed, particularly in the areas adjacent to the lake. As land becomes developed, the increased impervious surfaces contribute more polluted stormwater runoff. During rainfall events in the Table Rock lake watershed, some coves and distinct areas of the lake become visibly cloudy as a result of sediment washing into the lake from adjacent development.

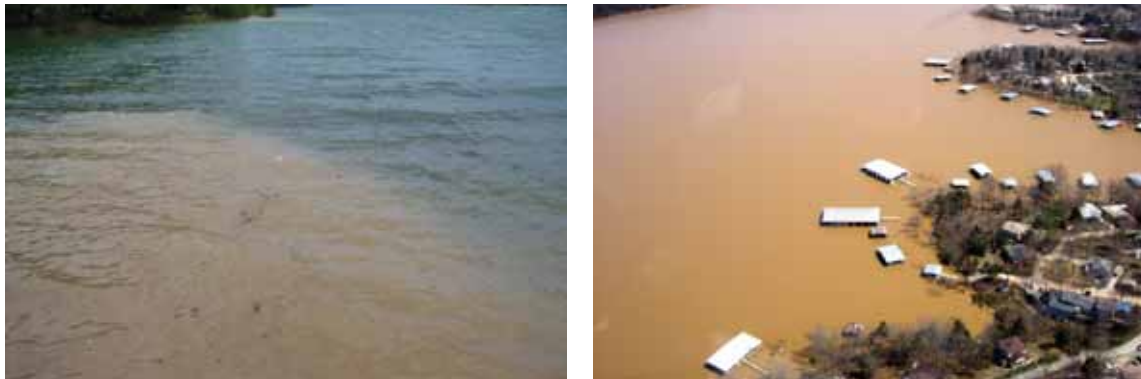
Below: Images of sediment washing into Table Rock Lake, during a normal rainfall event (left) and extreme sediment transport during the June 2008 flooding period (right).

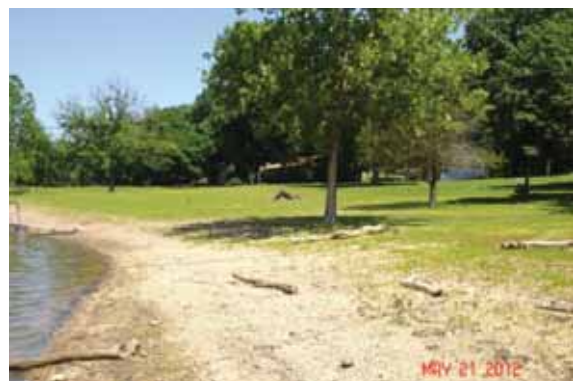
Kings River survey point showing the mowed lawn to the water's edge.

One of the more prominent issues with lake front communities that were found in the visual assessment was the fact that property owners mow or remove vegetation up to the water line. The U.S. Army Corps of Engineers actually prohibits removal of vegetation within their take line with limited allowances given to holders of a Corps-issued vegetative permit. However, enforcement and follow-up of the proper use of vegetative permits is often not feasible and cannot be adequately enforced due to limited Corps resources. TRLWQ and stakeholders agree that there is need to encourage homeowners to leave a buffer area of un-managed vegetation between their mowed portion of the lawn and the water line to help decrease stormwater runoff pollution entering the lake.

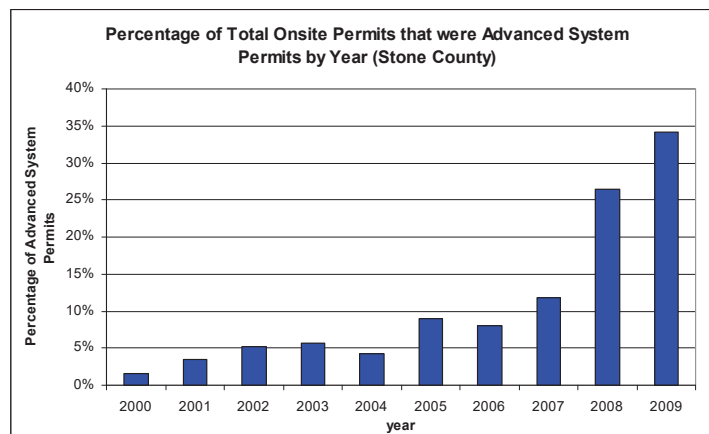
CHART SHOWS INCREASE IN THE PERCENTAGE OF STONE COUNTY SEPTIC PERMITS THAT HAD ADVANCED TREATMENT FROM 2000 TO 2009.

As new technologies are being accepted and proven for wastewater treatment, new and replacement septic systems in Stone County are seeing a shift from the conventional, gravity-fed tank and drain field to more advanced treatment systems. The advanced treatment systems contain, in addition to a septic tank, a pretreatment chamber with aeration to promote digestion of wastewater by bacteria. Pretreated wastewater is then pumped into dispersal lines or drip irrigation lines which spread it out in the soil for final treatment. Whether an advanced treatment or a conventional septic system is installed on a particular property depends upon the soils at that site. Since southern Stone County near Table Rock Lake often has very thin and rocky soils, many new advanced treatment systems are being installed in the southern portion of the county. These systems are required depending on soil analysis and provide much better wastewater treatment than the conventional septic system. The downside to advanced treatment systems, besides additional maintenance requirements, is costs, which is usually double or triple the cost of conventional systems.
